Phase 1: Same satellite, one setting changed

SIB19: the same geostationary satellite. The ephemeris is identical to the working run's: 42,164 km from Earth's center, over the equator, zero velocity. One NTN value differs: `cellSpecificKoffset-r17` is **270** here and 244 in the working run. That is 270 ms of scheduling offset at 15 kHz subcarrier spacing, against a round trip the srsRAN maintainer computed at 243.7 ms. In the issue thread the maintainer suggested 244 or 245. The working run, two days later, uses 244.

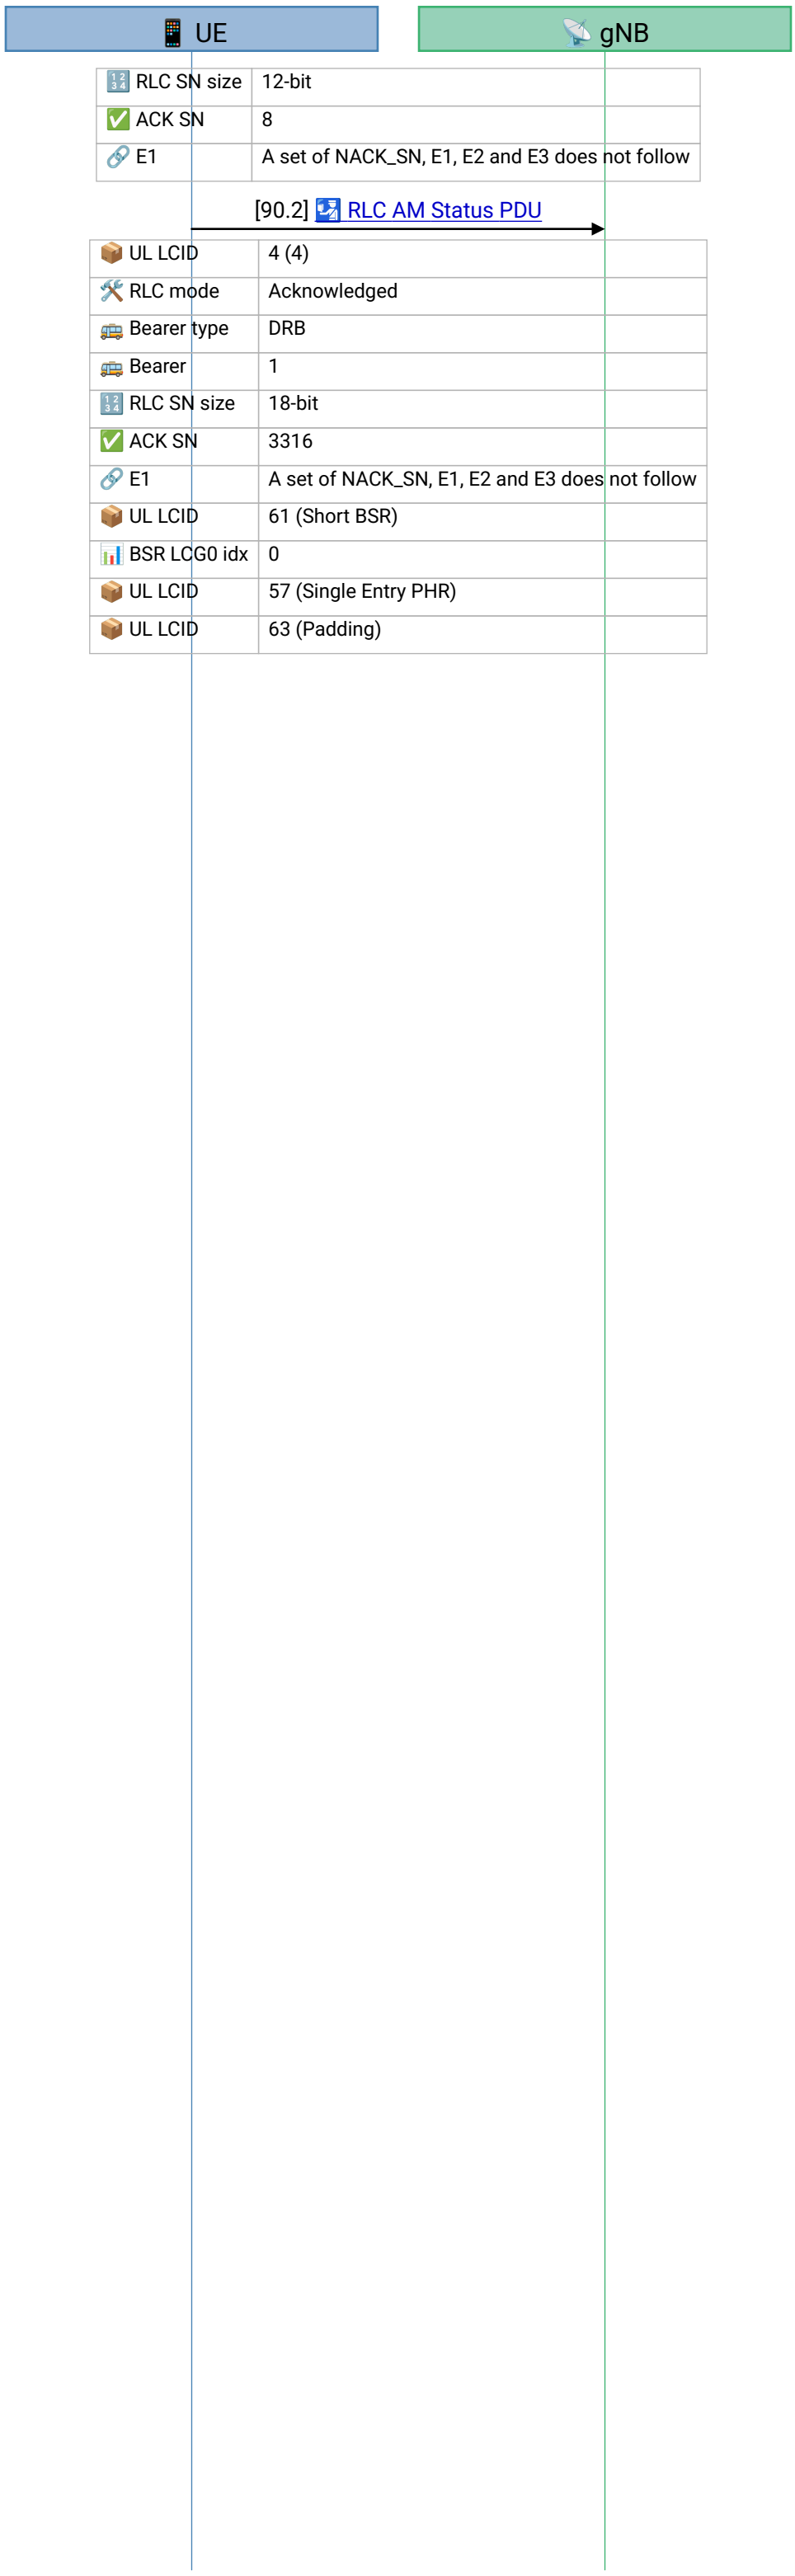
[Frame 90.2] And its data-bearer report: ACK_SN 3316. The UE received every one of the 3,316 PDUs. There is no NACK and no RLC retransmission anywhere in the full run.

That is the finding. The bearer did not lose data. The gNB declared the radio link lost while the data was arriving intact. The capture pins down what the two runs share (the satellite, the RLC timers, the 320 ms scheduling-request period) and the one NTN setting that differs, `K_offset` 270 against 244. Whether that difference is the cause cannot be proven from these captures. The reporter later wrote that failures continued at 244, and the srsRAN maintainers changed some timeouts to account for the NTN round trip in a later release.
